Rehabilitation of Sidi M'Cid Suspension Bridge, Algeria

Marco Petrangeli, Civil Eng.
Tecnoproject, Rome, Italy

Marcello Petrangeli, Civil Eng.
Freyssinet Italia, Rome, Italy

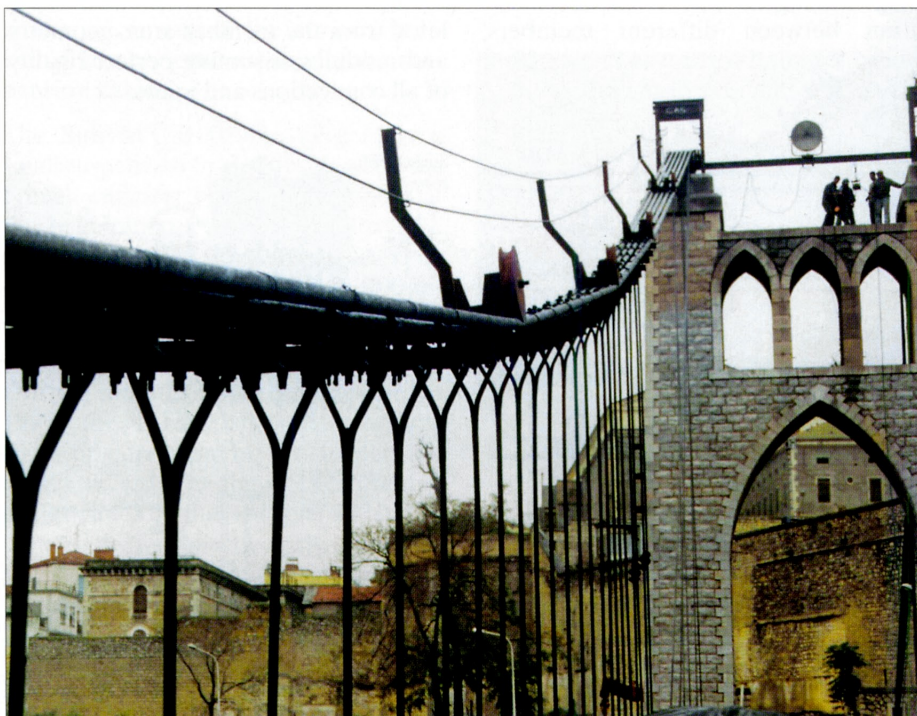
Fig. 6: Pulley and catwalk system along the main cables

A system was therefore devised where the ropes could be de-tensioned gradually, allowing them to move horizontally while recovering their stretch. This was achieved by placing a number of pulleys along the cables above the rope to be released (Fig. 6). The pulleys were integrated into the catwalk system and kept in place during the whole replacement operation (Fig. 7).

With the pulleys in place, all the clamps were released, irrespective of the phasing and order of the operation, with the rope transferring the up-lift force to the pulleys (roughly 40 kN per pulley). Once the ropes to be replaced were resting under the pulleys (Fig. 6), de-tensioning was carried out by releasing the ropes. This was performed by tying down the rope close to the pulley to be released and then pivoting the pulleys (Fig. 8).

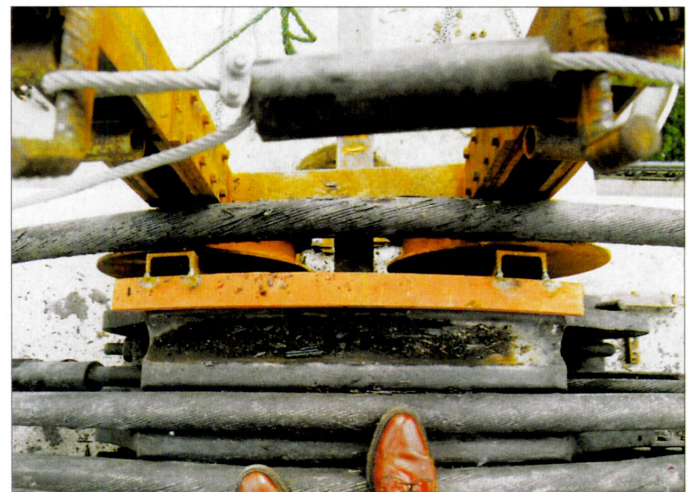
Fig. 9: Placing the rope over the pulleys at the saddles

Upon release of the first rope, friction at the saddle was significant. However, once the differential force overcame the friction, the rope slipped smoothly,

damped by the viscosity of the bituminous cable coat and by rust that had deposited in the saddle grooves over the years (Fig. 9).

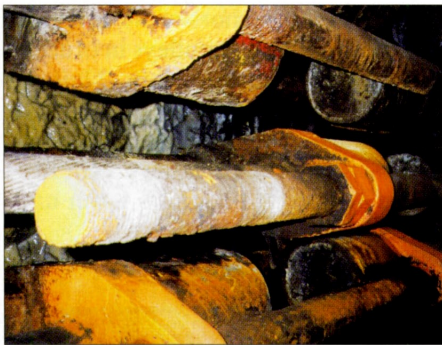
Fig. 11: Adjustable connection at the anchorages installed in the early 1980s

Replacement of the ropes had to allow for adjustment of the rope length and tension, and the original arrangement therefore had to be abandoned. During the rope replacement in the early 1980s, the problem was solved by splitting each rope into three parts and introducing two additional adjustable connections near the bottom of the tunnel (Figs. 11 and 12). This solution is very expensive because the three pieces require six sockets instead of two in the original configuration. The bars, nuts and washers used to join the ropes are particularly prone to corrosion, and the retrofitting work included replacement of half of the bars that had been installed less than 20 years ago (Fig. 11).

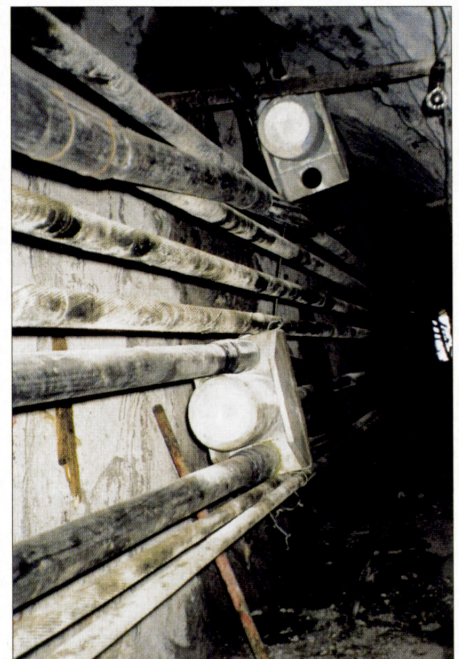
Fig. 13: New anchoring system with prestressing cables (the tunnel entrance can be seen on the right)

The solution has proved to be very efficient and easy to implement although two small side-effects had to be dealt with. The anchorage plate between the prestressing cables and the rope is quite large because the socket is thick and extra space was needed for the seven-strand prestressing block anchorages (Fig. 13). Making room for this element required some on-site adjustments because the existing ropes had slightly different positions at the four locations.

The torque developed by the ropes during tensioning was not counterbalanced by the prestressing cables, thus forcing the anchor plate to rotate. Because of the limited space, the anchor plate had to be restrained by greasing the surface between the socket and the plate so as to reduce friction and to force the anchor plate into position.

The coupling of ropes and parallel-strand cables as a means of anchorage has proved to be very efficient, although a purpose-made rope socket could minimise the size, which is likely to be a major concern for anchorages of any type.
